Manhole Inspection Summary

Manhole # S31MM1003MH

Location Address: **6 CHARLCOTE PL**

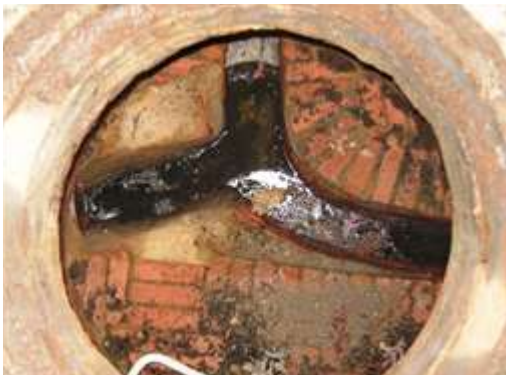
Top View

☐ Parged ☒ **Debris** (not Condition related)

☒ **Debris** (not Condition related)

☒ **Evidence Of Surcharge** Depth: **1** (ft.) ☐ Active Surcharge Present

Evidence of surcharge - Bench debris.
Channel debris.

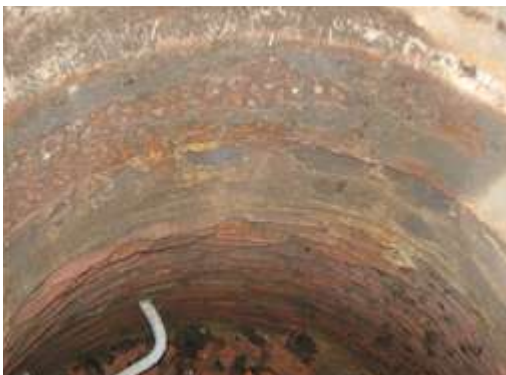
Defect

Infiltration: ☐ None ☒ **Joint** ☐ Cracks ☐ Mortar ☐ Roots ☒ **Wall**

Infiltration: ☐ None ☐ Joint ☐ Cracks ☒ **Mortar** ☐ Roots ☒ **Wall**

Infiltration: ☐ None ☐ Joint ☐ Cracks ☒ **Mortar** ☐ Roots ☐ Wall

Adjsutment, Corbel and Barrel infiltration.

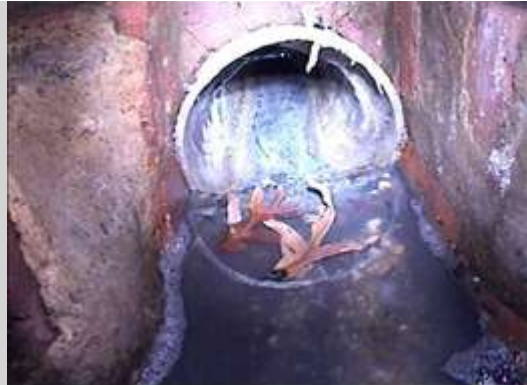
6 in. Circular Gravity Sewer Pipe Out @ 12 O'Clock

Deposits: ☐ None ☒ **Mud** ☐ Sludge ☒ **Debris** ☒ **Grease**

Silt Depth: **0.5** (in.) Deposits Extent: **Light**

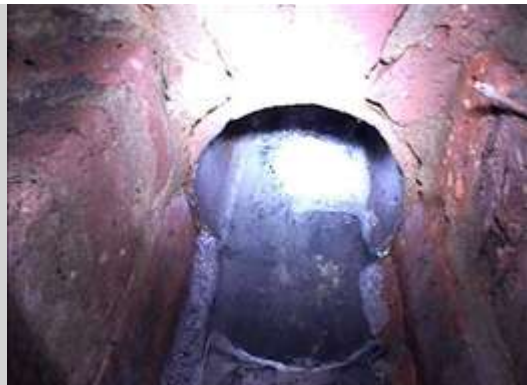
6 in. Circular Gravity Sewer Pipe In @ 3 O'Clock

Invert Depth: **6.48** (ft.) Flow Characteristics: **Slow**

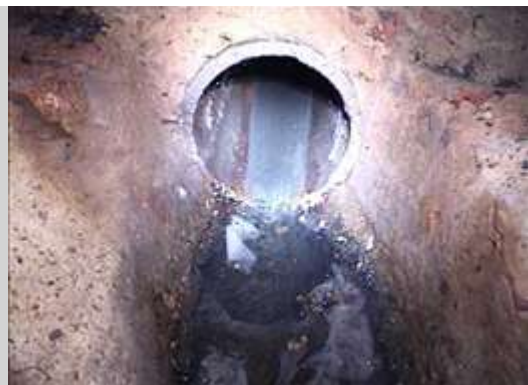
6 in. Circular Gravity Sewer

Deposits: ☐ None ☐ Mud ☐ Sludge ☐ Debris ☒ **Grease**

Deposits Extent: **Light**
